Battling BOLT from the Blue

By Guy Meilleur

Much of the 520 acres is covered with row after unbroken row of gravestones, and more will be added until the cemetery is full to the fences. The scattered trees stand sentinel, shading and softening the soldiers' final resting ground. Several are antebellum "witness trees," also veterans of the Civil War. Coordinated by urban forester Eric Gansauer and the Georgia Arborists Association, arborists with TCIA member companies Arborguard Tree Specialists and Downey Trees joined dozens of others to care for these veteran trees that watch over the graves of fallen veterans. This article is about one tree in particular that serves to remind us of something near and dear to arborists' hearts—the importance of tree preservation. Following is a report on that tree, No. 263:

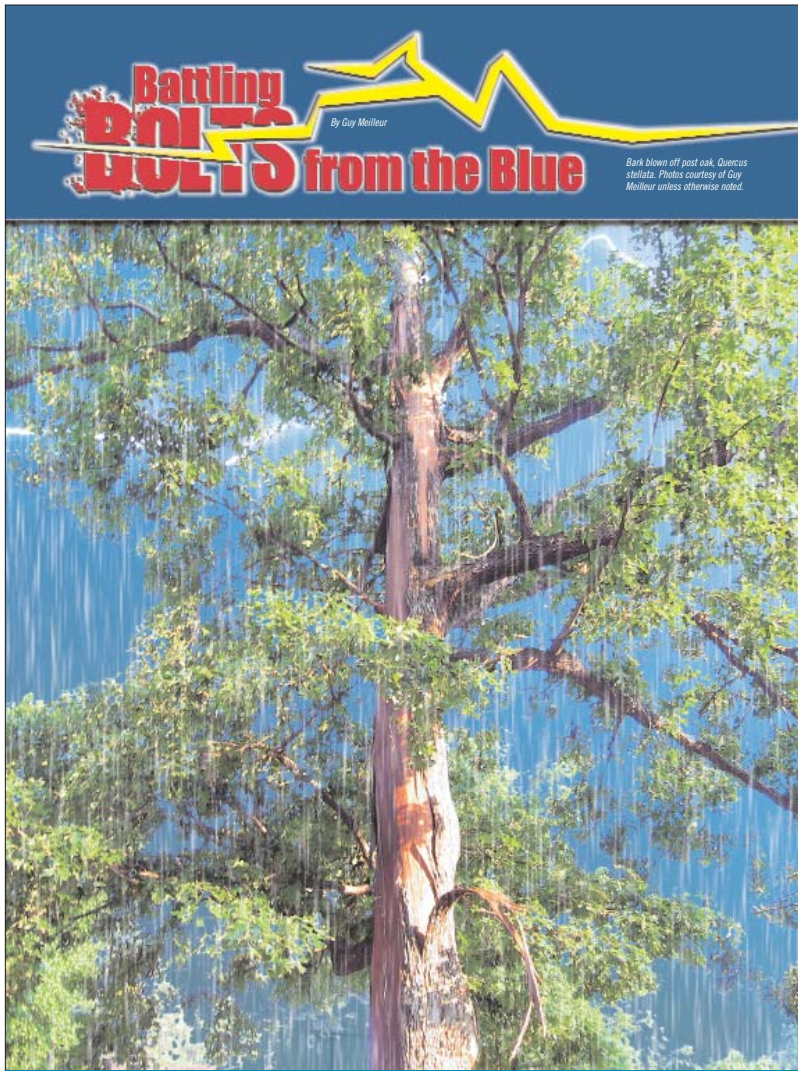
Bark blown off post oak, *Quercus stellata*. Photos courtesy of Guy Meilleur unless otherwise noted.

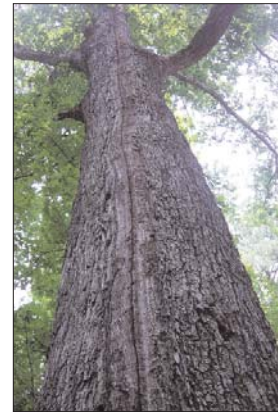
I noted four separate streaks of wood down the stem of tree No. 263, at approximately right angles to each other. The widest wound ran from the base up to the first primary fork on the northwest side and back down the other side. A small crack started at that fork, and there was active decay in a pocket above the crack, just below the fork. A large, fat sink was living under the detached bark.

Andersonville — Wound at main fork of landmark post oak. No callus growth in five years, decay advancing, root damage increasing, high target rating; fatal damage from lightning strike. Courtesy Chip Hillreth, ArborCarolina

With one-third of the bark blown off the trunk, and a 20-inch-wide wound above the first fork, this lightning damage seemed terminal. This fork seemed at risk to fail in a moderate summer storm, but it could be cabled to buy some years. However, it is only a matter of time before cracking and decay render the lower trunk unstable. Poor root health and more excavation for graves mean this time will come fairly soon, despite the wood's resistance to

Superintendent Boyles made the tough decision to remove tree No. 263. He also made a much easier decision – to apply for funding to protect the remaining landmark trees from future lightning strikes.

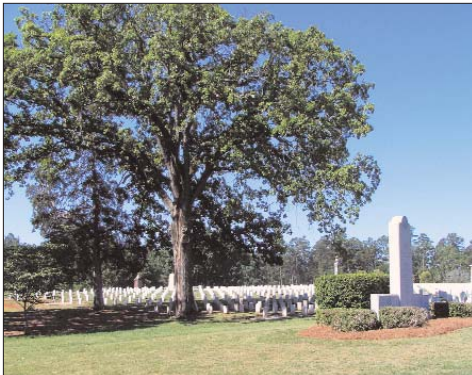
Tree No. 263 posed a high risk in the near to medium term. The long-term risk

can only be abated by removal. Trees No. 219 and No. 220 posed a low risk until their roots are excavated.

Tree #263 at Andersonville did not recover from lightning wounds. It will be felled by the friendly fire of chain saws.
