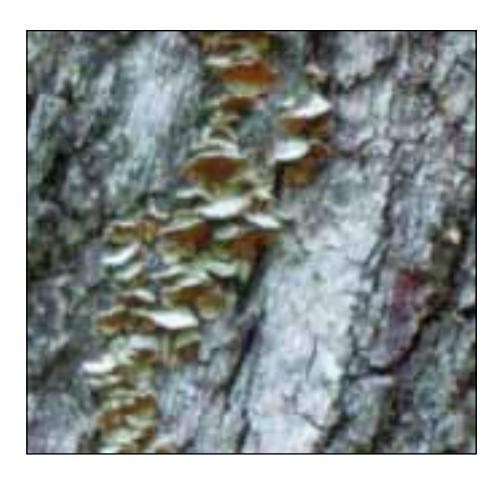
Decay streaks down the sides.

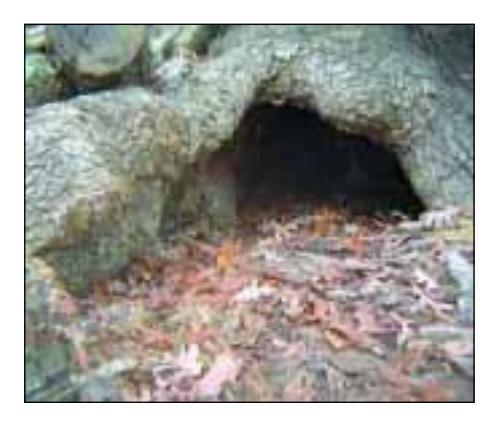
Hollowed buttress root.

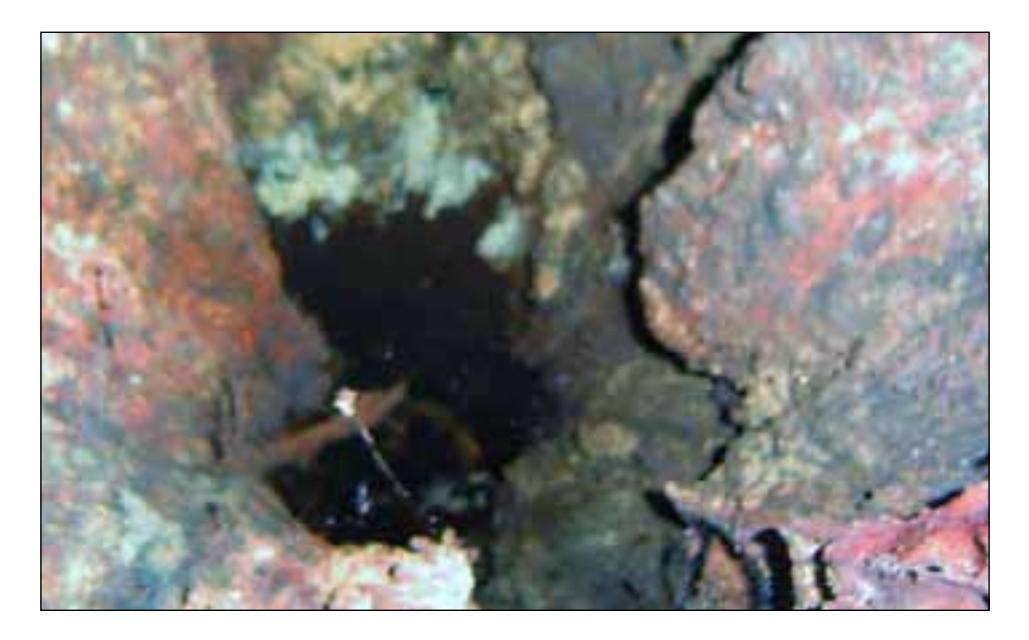
Looking up the cavity from the center of the tree.
