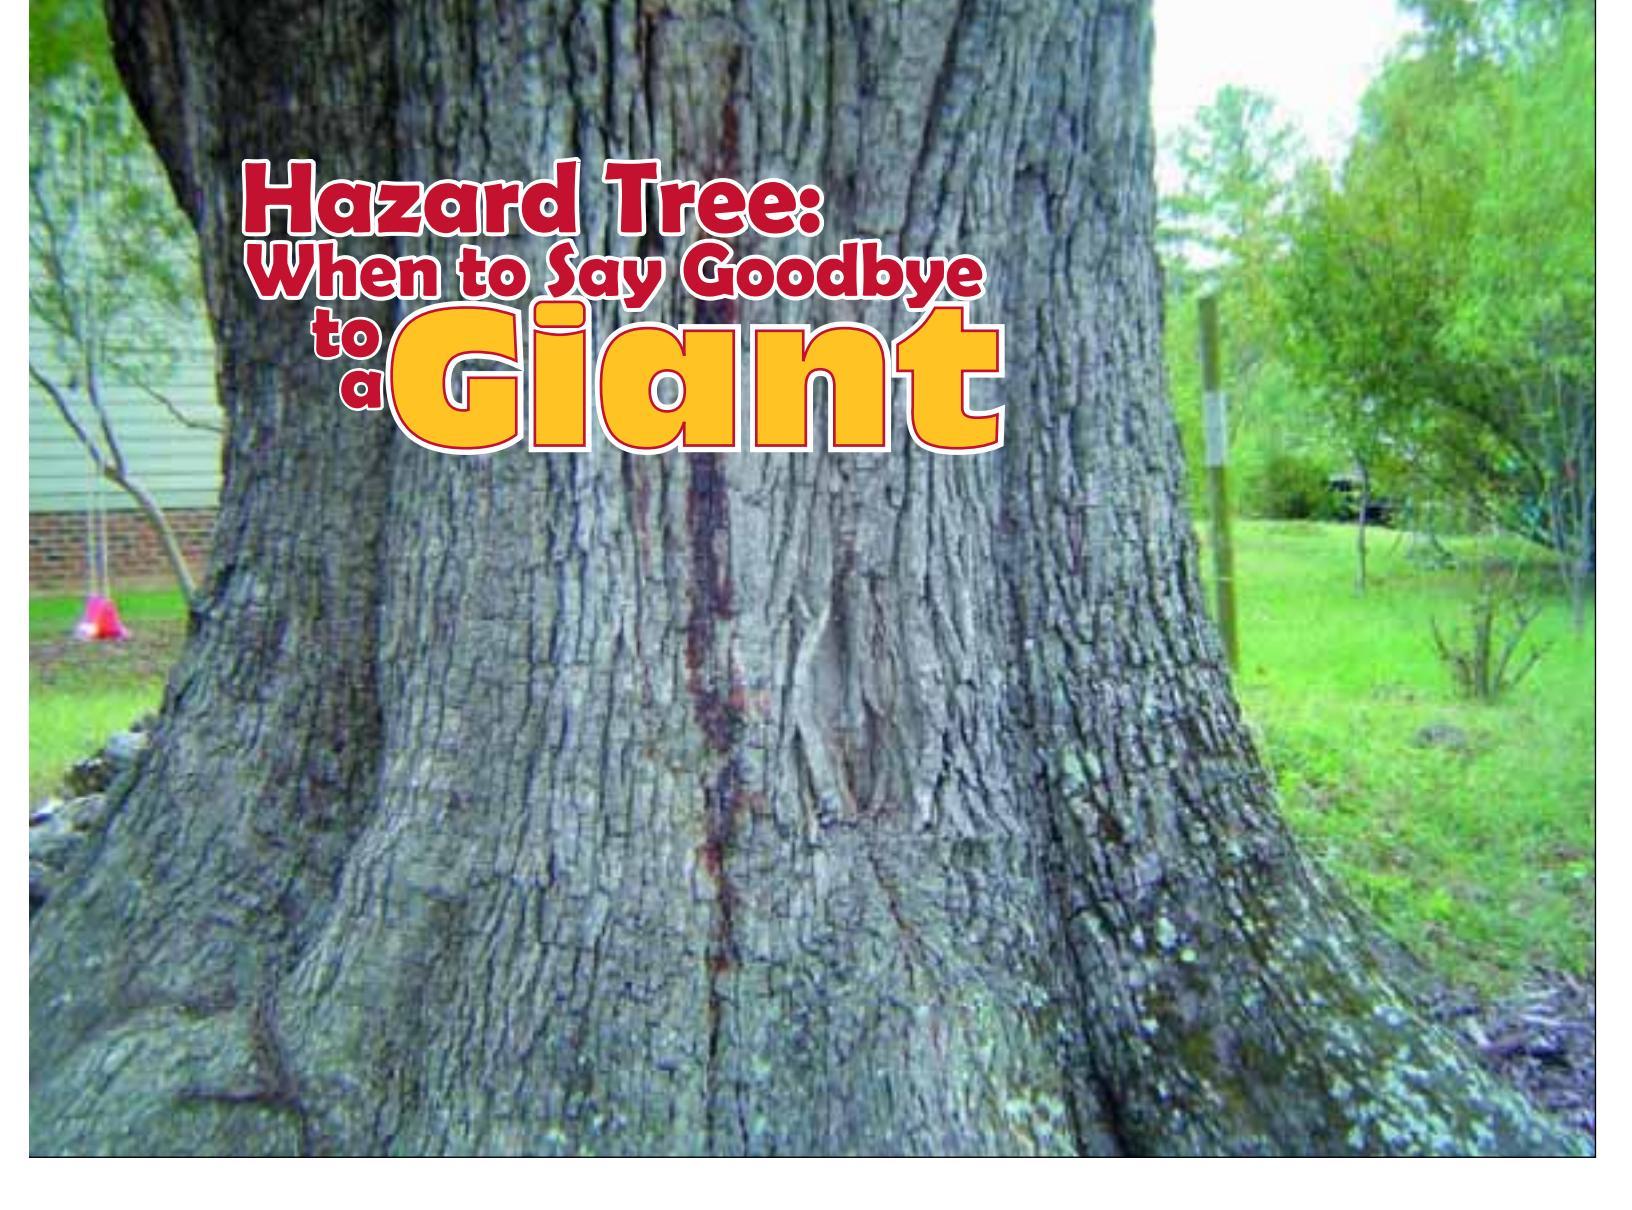
Bleeding lesion in a furrow opposite from the open cavity, a sign of advancing decay.

A moist summer was followed by a severe September drought. The entire top is dead, so the whole tree is structurally unstable. A bleeding lesion on the side of the trunk opposite the cavity signifies advancing decay. One spouse sees all the green leaves on the lower limbs, so he still wants to keep the tree. The other
